Technical Notes by Dr. Mel

January 2005

TRI Solutions For Common Problems of Extension Shafts, Oil Pumps and Steady Rest Bearings For Westinghouse Large Steam Turbine Generators

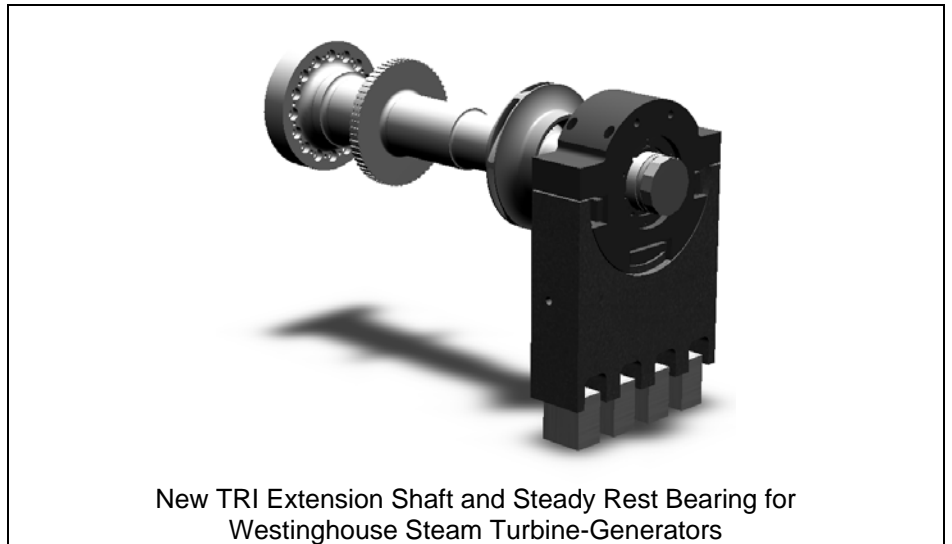
New TRI Extension Shaft and Steady Rest Bearing for
Westinghouse Steam Turbine-Generators

When no steady rest bearing exists, the preferred solution is to replace the existing extension shaft with a new TRI extension shaft and install a very substantial steady rest bearing at the outboard end of the extension shaft. The TRI Align-A-Pad® Bearing has proven to be an ideal solution.

When a 4-pad Westinghouse steady rest bearing already exists, the preferred solution is to replace it with a new TRI Align-A-Pad® design.

The TRI Align-A-Pad® Bearing for this Steady Rest application has 5 tilting pads with heavy duty pad support contacts. A new heavy pedestal is included in the design, which can be modified to extend down to the floor of the front standard and/or attached to the front wall of the front standard. The bearing is equipped with 3 “saddle blocks” or alignment pads to align the bearing relative to the new heavy pedestal. This TRI solution has been in service for over 10 years with very low vibration and almost no maintenance.
